RESEARCH CONSTRUCTION REPORT

Thin-Whitetopping Overlay Composite

Location: Kalispell, Montana

Project No.: STPP 1-2 (93) 121 East Idaho St.

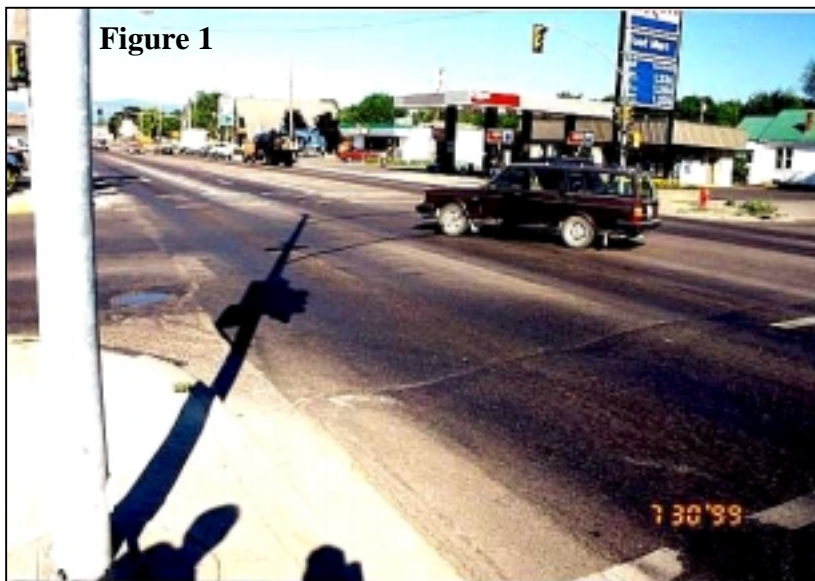
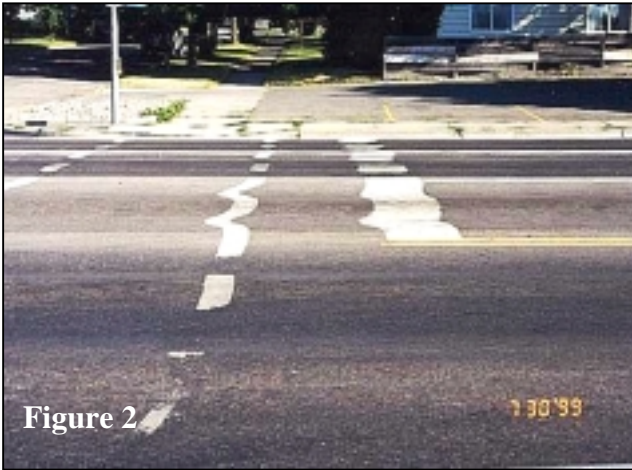
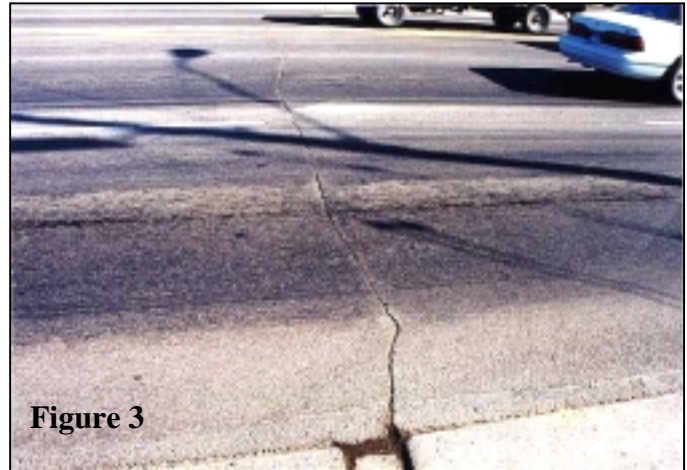
East Idaho St. was suffering severe rutting, plastic deformation and transverse cracking with the current AC pavement. The Montana Department of Transportation decided to construct a thin-whitetopping project based on pavement preservation. Whitetopping is an alternative to the regular program of mill & fill. This procedure bonds a flexible layer to a rigid layer to form a composite pavement to eliminate rutting and plastic

deformation. This report will document events from the researcher point of view. Not all events were document in this report. This effort is to establish a baseline of documentation that will assist with future performance evaluations with this project. Figures 1-3 showed East Idaho before construction.

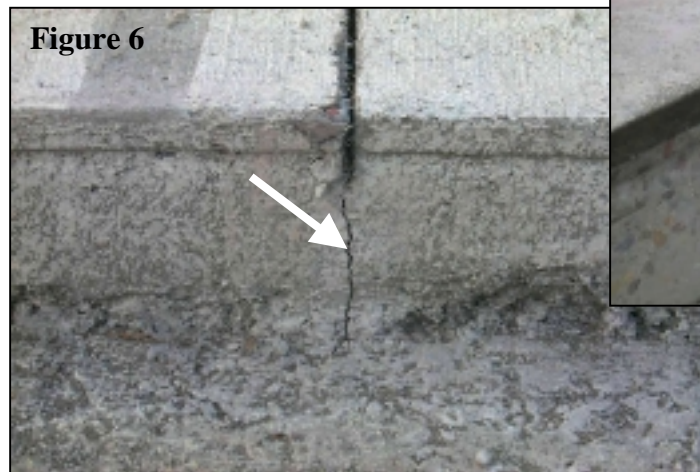
did show how well the PCCP had bonded to the asphalt layer. To bust away the sawed portion of concrete a forklift was needed. The removed pieces had asphalt still attached to the PCCP. Figure 7 shows approximately, how much material was removed. Figure 6 is a

representation of the cracking at the saw cut joint. This cracked within several days after placement.

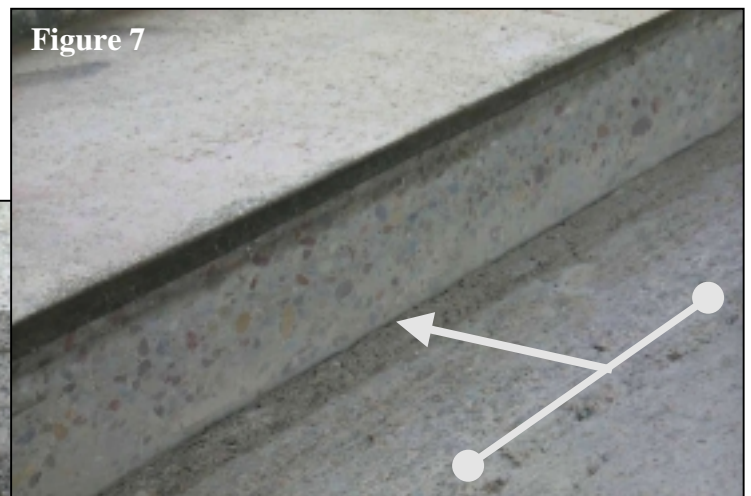
Figure 7

be added to the concrete in the mixing truck. In addition, water was being added to promote smoother flow down the chute. Apparently, the amount of fibers (3lb. Per cu/yd) in the mix was clumping in the chute and the driver felt it was necessary to add more water. This in turn increased the slump to a level in which while finishing the exposed (northern edge) of the placement it sloped downward, no longer a flat surface. Figure 5 shows the slumped edge and the spillage left behind from the paver. Since this edge would no longer match the edge when the deck paver would be used the contractor was asked to remove approximately 2/10 of a meter

from the edge of the sloped area. This was done by saw cutting down to the AC layer. Although this was an unfortunate event to the contractor, it

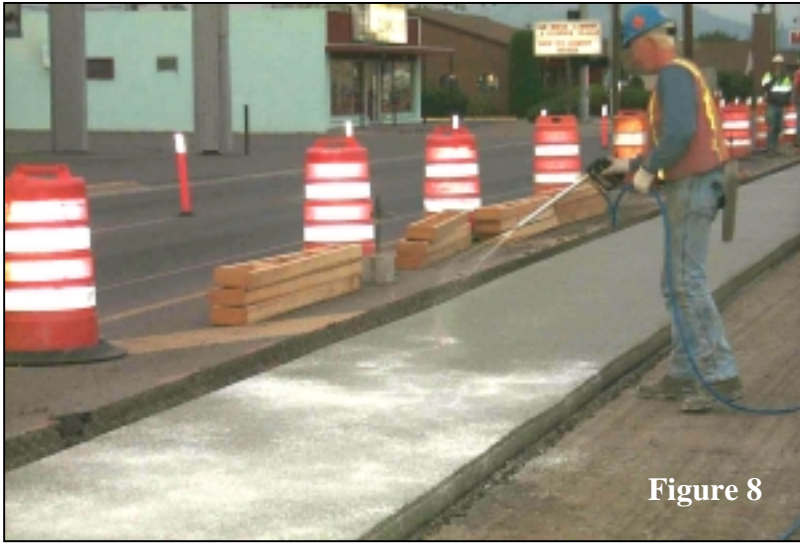
Figure 8 is showing the application of water-based latex curing compound. The worker was having difficulty in applying a uniform layer of compound. The sprayer head and tank pressure was not tested before application.

After trial and error, this was corrected and the contractor placed the compound by the approved method. Prior and down the street.

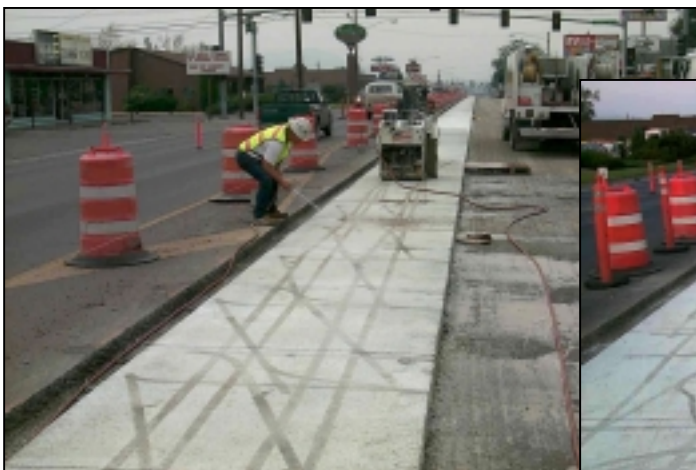
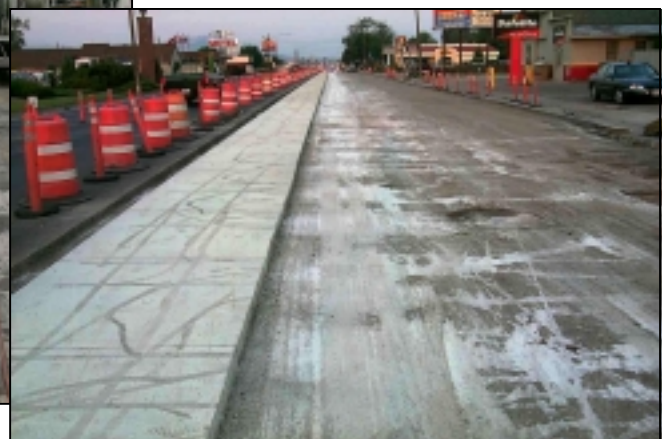
During the saw cutting of the westbound slip-form section, the contractor allowed the saw slurry to drain and wash onto the cleaned, milled asphalt as seen in the images below.

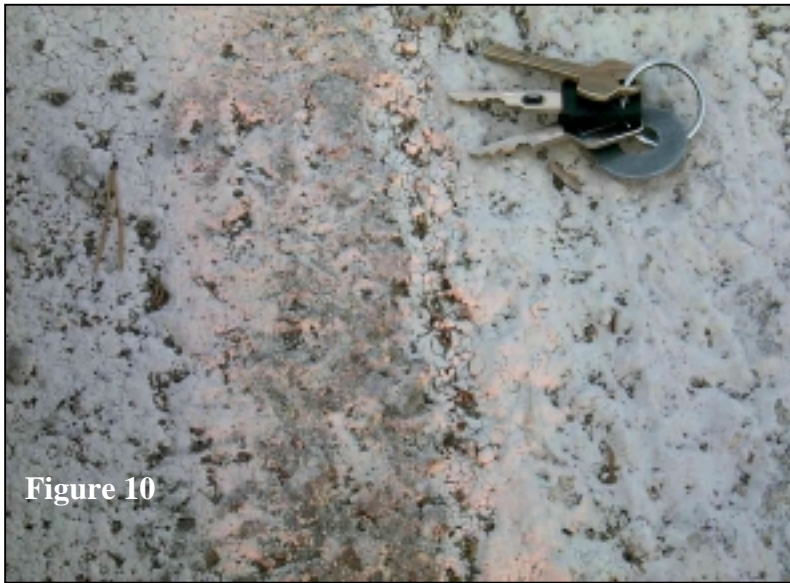
Figure 10

When the slurry had dried it left behind a friable material (Figure 10) that could be easily removed with a fingernail. A substantial coating of this slurry had been deposited on the surface of the milled asphalt. This material would interfere with the bonding of the PCCP to the asphalt layer. Vacuuming and sweeping was repeated with this stretch of the project to

remove the slurry wash. The surface was restored to its original condition before the saw cutting.

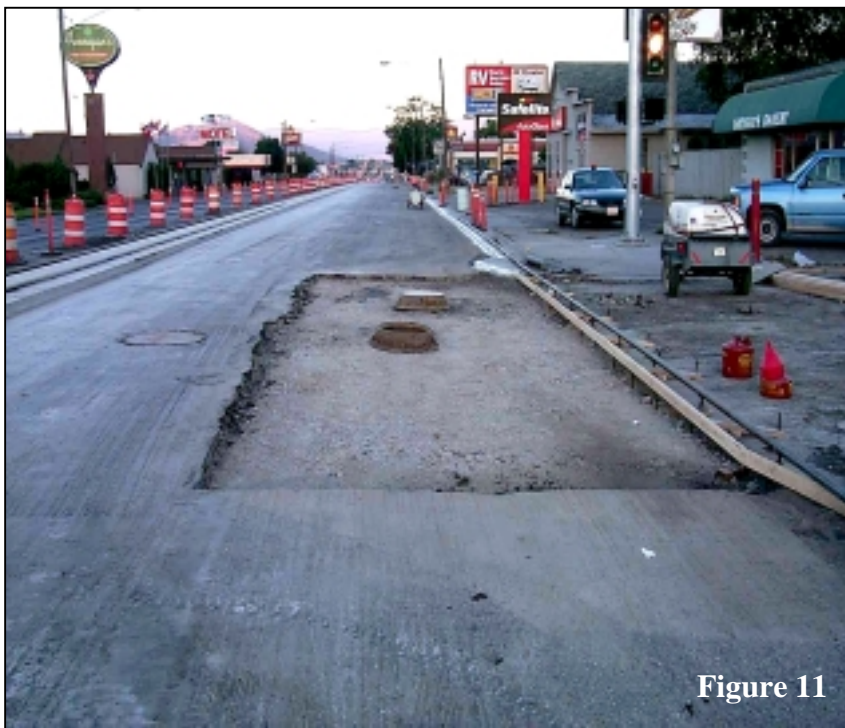
Figure 11

At the intersection of 7th ave. and East Idaho there was found to be an insufficient thickness of asphalt to support the PCCP Layer (Figure 11). The thin layer of asphalt was removed to perimeter with sufficient extent to the asphalt layer of necessary thickness. Then the asphalt was removed completely to the base material. During placement of the PCCP, this would allow the cutout section to be full-

depth with the passing of the Bidwell Paver. This procedure is an acceptable method to deal with this type of situation. The full-depth section as placed did not affect the pattern of saw cutting. Nor was any doweling used. The storm sewer insert and cap were not part of the cutout section.

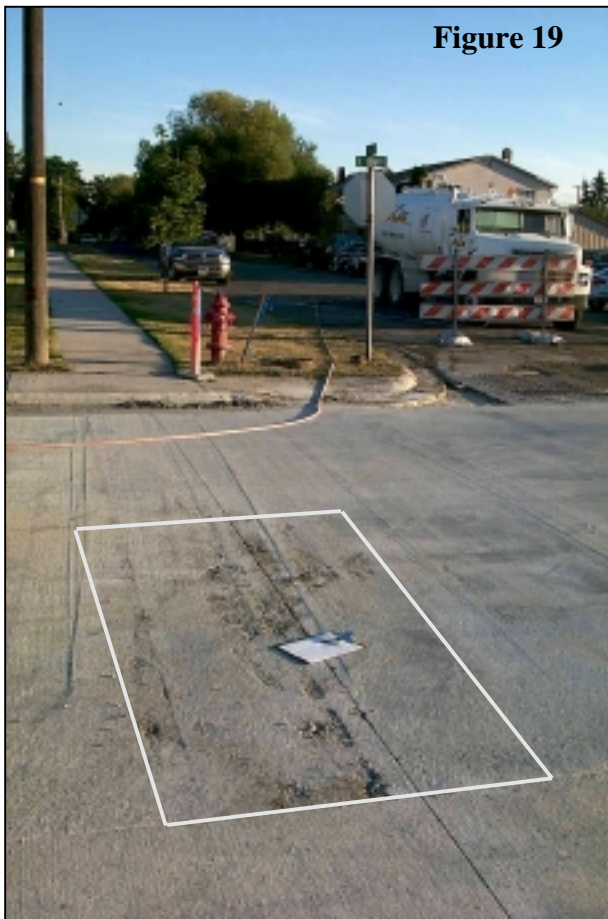
Figure 19

placement, there should have been two vibrators used in this project. This most likely was the reason on a small section of the placement that the PCCP was not vibrated sufficiently to remove the pockets left by the workman's boots. The yellow outline on figure 19 approximately shows the lack of consolidation. The circumstance that caused this to happen was quite clear. The workman operating the stinger took a very short break to quickly eat. While doing this, the paver continued to operate and proceeded to move over the spot that had not been vibrated. This unconsolidated section looked fine until the saw crew began cutting at this spot. At that time the weight and action of sawing breached the PCCP.

Upon consultation with MDT and the Prime, it was decided to remove the section of damaged concrete. Corings were taken to ascertain the extent of damage. The area was then removed by

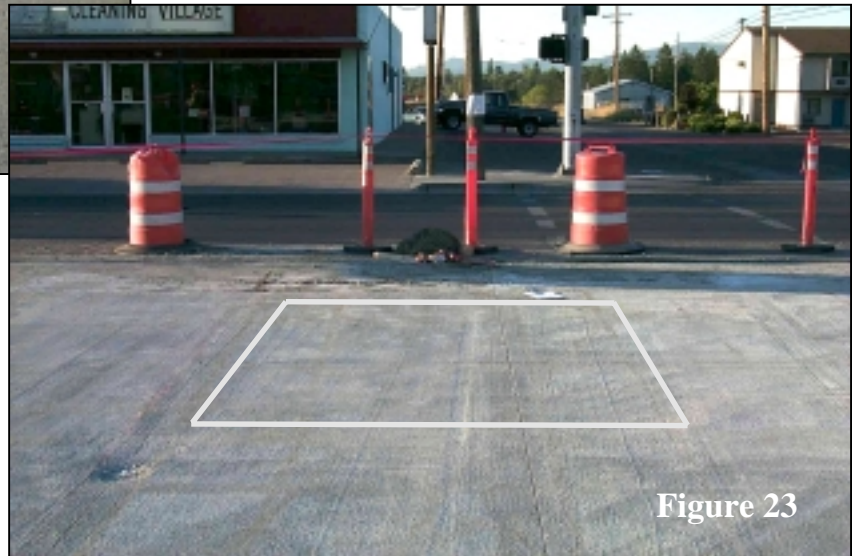
Figure 23

At the intersection of East Idaho & 7th Ave EN, hydraulic oil was spilled while the PCCP was being placed in the westbound, left lane (Figure 23). Apparently a hydraulic hose, which operated the concrete chute, failed during placement. Oil then pored directly into the PCCP. The paver was halted while the contractor attempted to remove the substance. The contractor did do a plausible job in removing as much oil as possible. However much still remained in the placement, and an oil sheen could be seen on the surface after finishing. The yellow outline is the approximate area of contamination. Research will monitor this area closely for potential failure of the PCCP.
